19th & Early 20th Century Architecture of Dunmore Town

Extracted from The Dunmore Heritage Audit, Co Galway 2020/2021 by Zena Hocter. This project received grant aid from Galway Rural Development which is financed by the Irish Government under Rural Development Programme Ireland (LEADER) 2014 - 2020 and by the European Agricultural Fund for Rural Development.

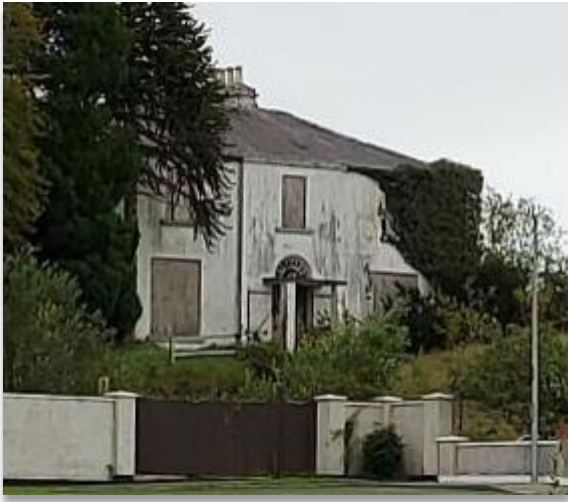
Photograph: Sion Hill (The Glebe) 2020

The house is set on its own grounds adjacent to 'Friars Walk' Housing Estate. It has a shallow breakfront to the entrance bay and a flat-roofed entrance porch with a flat concrete roof supported on square columns. The porch was added c.1920. The six-panelled double-leaf timber front door has an elaborate Adam-style fanlight with radial glazing bars forming a central orb and each segment ending in an ogee arch.

There are single-storey, rubble stone outbuildings to the rear of the house. The house is now derelict and the square-headed windows are boarded up. The house is a listed protected structure on the National Inventory of Architectural Heritage (NIAH Reg. No. 30330006).

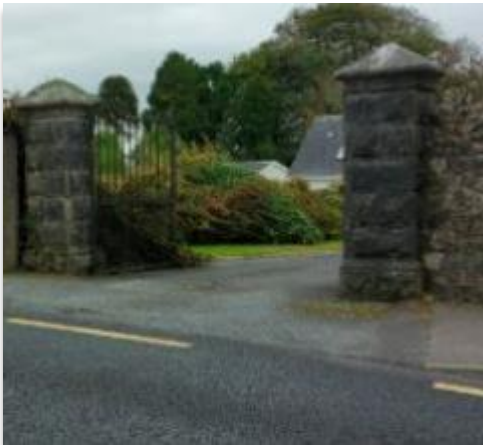
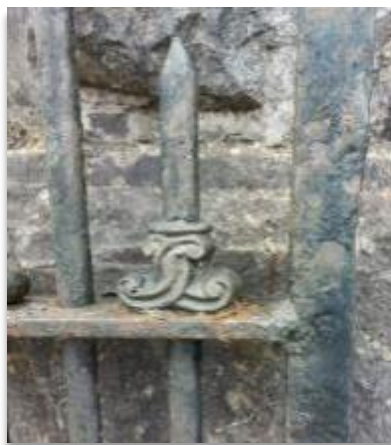
The set of stone piers and cast iron gates on Sion Hill opposite the National School, mark the original back entrance way to the house. They are not original to the house but were purchased from a Convent in Ballyhaunis Co. Mayo in the 1970s. (Information from Renate Cooke to Joan Walkin). The main entrance to the house was located close to the present day entrance to Friars Walk housing estate.

Photographs: Back entrance cast iron gates and stone pillars to the former Sion Hill House (The Glebe)

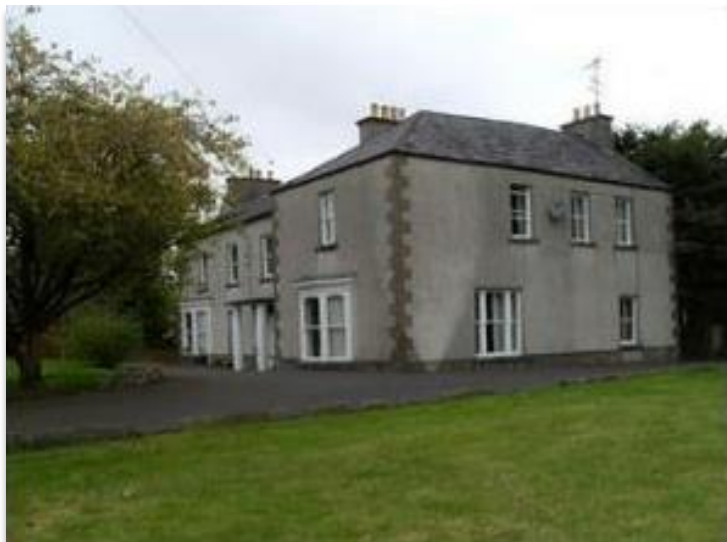
Set in its own grounds this simple Georgian style house is composed of a detached four-bay two-story block built c.1810 and a three-bay additional block added c.1830 to the side. Two Victorian-style canted-bay windows were added to the front of the house c.1880. The grounds are enclosed by rendered walls and metal gates. The house has a natural slate roof which is pitched on the older block and hipped on the later block. The walls are roughcast rendered, with dressed limestone quoins and plinth. The timber eight-panel main entrance door is flanked by sidelights. A flat concrete canopy supported on cylindrical cement columns shelters the doorway. The house is a protected structure listed on the NIAH (Reg. No.: 30330003) and on the RPS.

Photograph: St Mary's House Dunmore

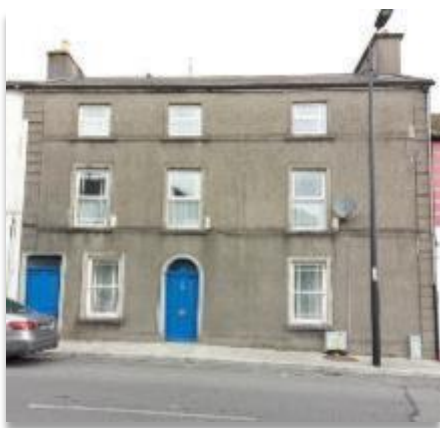
The terraced three storey house in High St. was built c.1820 and retains its original proportions and use. It has a four-bay ground floor and three-bay upper floors. The walls are cement ruled and lined with probable rubble stone beneath. The square-headed windows have raised moulded cement surrounds and limestone sills. The ground floor windows are the original margined timber sliding sash one-over-one pane but the upper floors have replacement uPVC windows. There are two doorways at ground level. The round-headed doorway has a spoked timber fanlight, while the square headed doorway has an overlight. Both have 19th century timber panelled doors. The house is a protected structure listed on the NIAH (Reg. No.: 30330010) and the RPS.

Photograph: House on High St., Dunmore

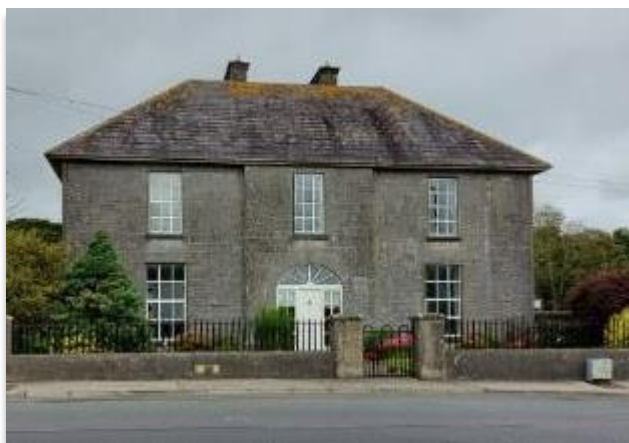
The Parochial House on High St is a detached three-bay two-storey L-plan house which was built c.1820. On the 1890 OS 6-inch map, it is labelled as 'Merton House'. It is placed in a strategic position facing down the street opposite and is set back from the street with wrought-iron railings on a rendered plinth wall and a decorative wrought-iron pedestrian gate set between a pair of limestone piers with caps. The façade is of fine squared limestone with rendered ends. The hipped roof has graduated slates which are now quite rare.

Photograph: Parochial House, Dunmore

The rendered chimneystacks are set behind the roof ridge. A shallow entrance breakfront has a wide segmental-headed doorway with a replacement timber door and fanlight. The tall square-headed windows have limestone sills and replacement uPVC glazing. The house is a protected structure listed on the NIAH (Reg. No.: 30330013) but it is not included on the RPS.

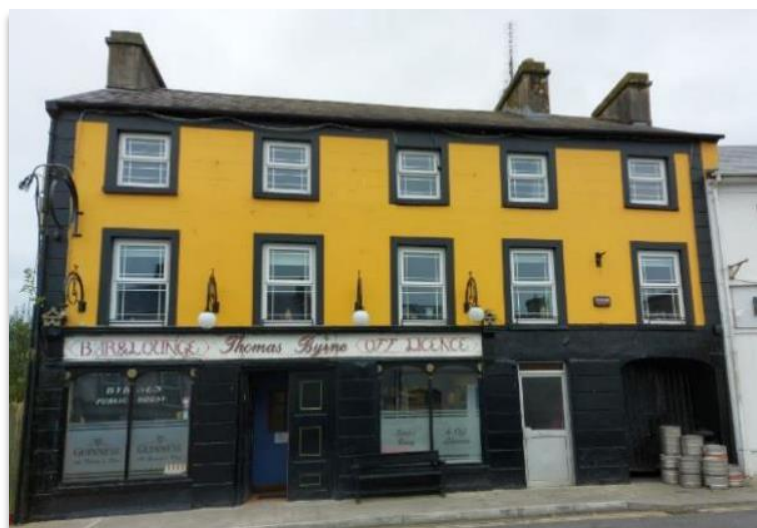
The shopfront is set into a terraced five-bay three-storey house with an integral carriage arch to the ground floor. The house was built c.1830 and the shop frontage added c.1870.

The building has a low pitched natural slate roof with three rendered chimneystacks. The rubble limestone walls are rendered and painted, ruled and lined on the upper floor and channelled on the ground floor. The square-headed window openings on the upper floors have stone sills and raised render surrounds. They are replacement uPVC windows.

The shopfront is defined by decorative pedimented brackets, a plain fascia with a moulded cornice and painted lettering. A central double-leaf panelled timber door is flanked by two display windows divided by a central mullion. The building is listed as a protected structure on the NIAH (Reg. No. 30330012) and also on the RPS.

Photograph: Thomas Byrne Bar and Lounge, Dunmore.

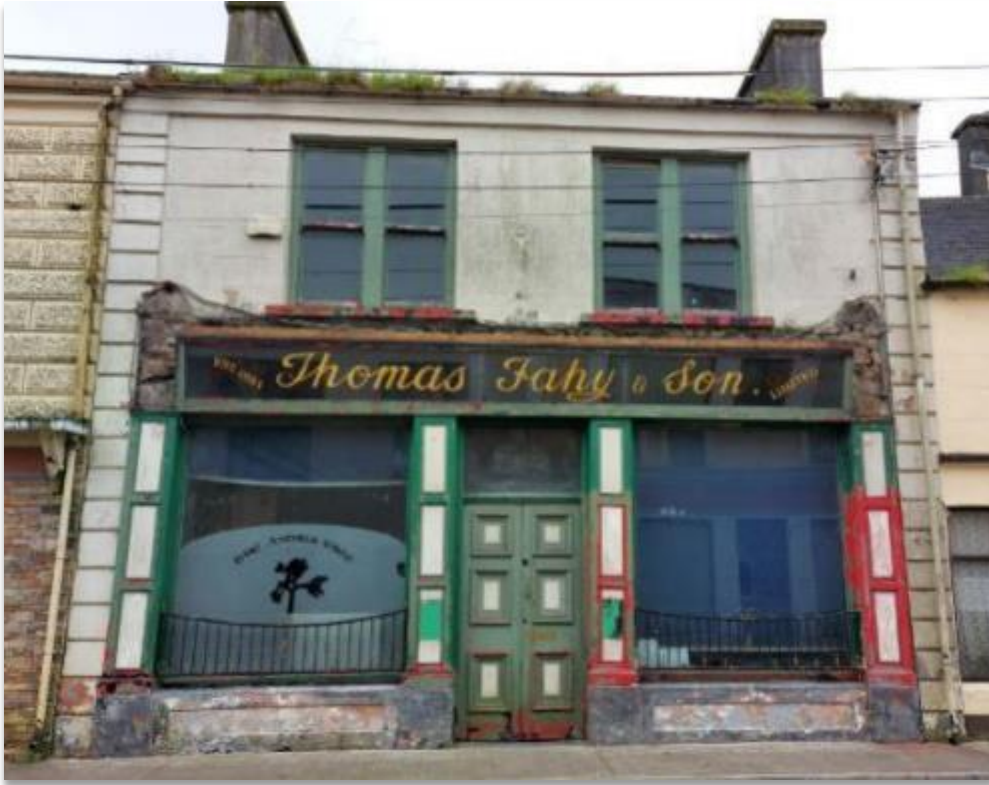
Photograph: Thomas Fahy & Son Public House 2020.

This terraced two-bay two-storey house was built c.1830 and a public house front was added c.1881 to the ground floor. The building was remodelled c.1910. There has been a marked dilapidation of the building and shopfront since it was recorded for the NIAH inventory in 2009. In 2009, the NIAH described it as ‘the fine render shopfront is one of the best in Dunmore and the incorporation of mirrors into the brackets is unusual and decorative’.

It has a pitched slated roof with rendered chimneystacks and the walls are rendered and painted with parallel, raised quoins. The shopfront has panelled pilasters with plinths and brackets which were recorded as incorporating mirrors by the NIAH. The double-leaf timber panelled entrance door has a rectangular overhead. The display windows are protected by wrought-iron railings. The building is listed on the NIAH (Reg. No.: 30330008) and on the RPS.

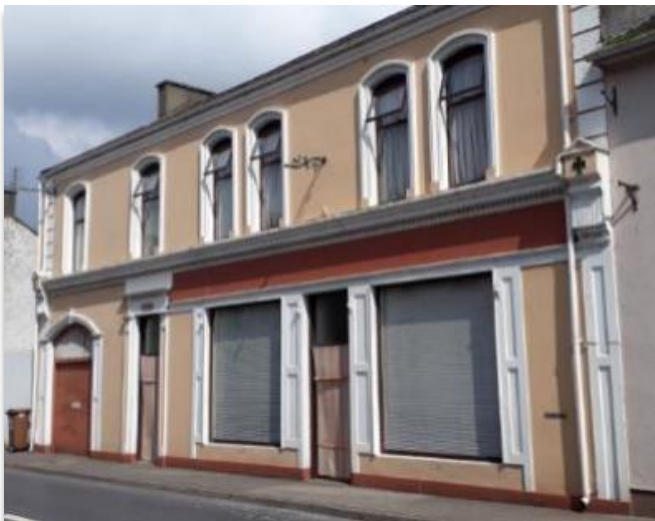
Photograph: Former shopfront, Castle Street

The building is a four-bay two-storey terraced house, dated 1902, with a shopfront and integral carriage arch to the ground floor. The front is rendered with raised plaster quoins.

The whole of the ground floor is capped by a moulded cornice at first floor sill level. Panelled pilasters with fluted consoles and pediment tops with shamrock motifs bookend the ground floor.

The carriage arch at the north end is flanked by panelled pilasters and topped with a moulded arch with a fluted keystone. The first floor windows openings are camber-headed with moulded architraves and replacement timber casement windows. They are grouped in two pairs to the south end.

The timber entrance door is square-headed and flanked by decorative pilasters with moulded panels and has ornate brackets, a moulded cornice and dentil course, with a date plaque between brackets.

The shopfront also has panelled pilasters with square-headed display windows set between them. The centrally placed, square-headed shop door has an over light. A decorative wrought-iron bracket extends from the first floor and was possibly used for signage. The building is listed on the NIAH (Reg. No. : 30330007) but it is not included in the RPS.

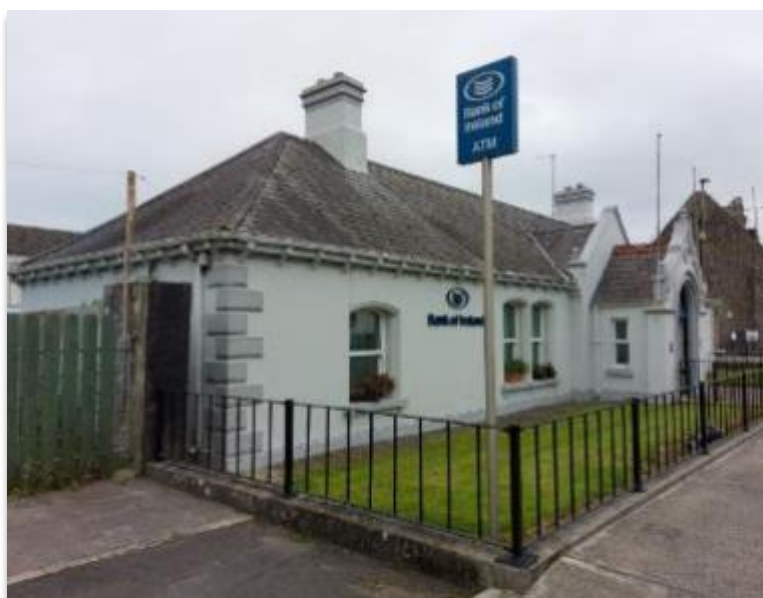
The building that formerly housed the Bank of Ireland, though typical in detailing of a late Victorian bank building, is unusually single storey. It is sited on Barrack St and has a small grass area to the front enclosed by metal railings on a rendered plinth.

The detail of the elaborately moulded entrance porch and timber roof brackets make it a unique feature of the town's architectural heritage. It was built over one hundred years ago c.1880,

Photograph: Former Bank of Ireland Dunmore

It is a detached five-bay single-storey building with a gabled breakfront which houses the main entrance round headed doorway. The breakfront has render copings with ball finials and apex detail, and the projection to which it is inset has a curvilinear gable with ball finials to ends. The roof is hipped with carved timber brackets. It has a natural slate roof with two rendered chimneystacks with moulding copings. The walls are rendered with raised plaster quoins and a moulded plinth. The windows are camber-headed with moulded surrounds. Double windows flank the porch. The painted stone sills have decorative brackets beneath. One of the window openings has been converted for use for the ATM.

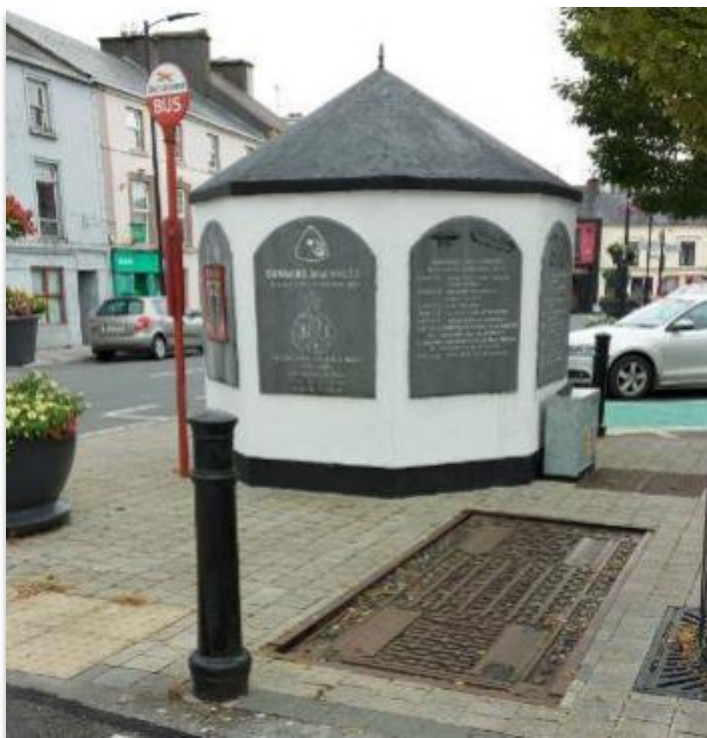
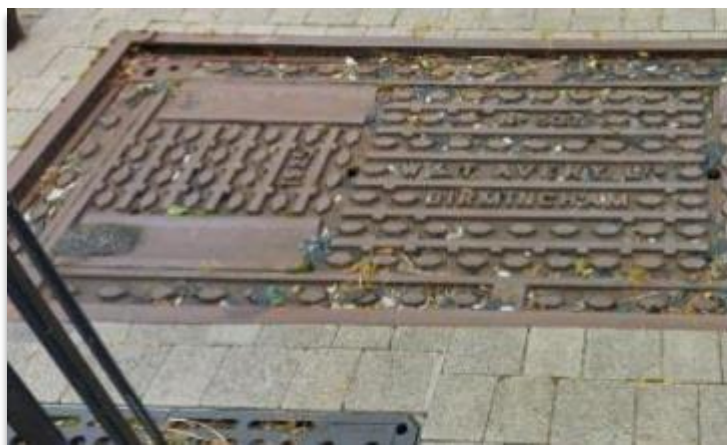
The octagonal-plan single-storey weigh-house has a conical roof and rendered painted walls. A square headed doorway is located on the north side. Limestone plaques commemorating local history and events have been inserted around the exterior wall

Photographs: Weighbridge and House, the Square, Dunmore

The decorative cast-iron weighbridge is located on the south-east side of the house. There are four wheel channels at the corners. The makers name and date 'W&T Avery Ltd Birmingham 1925 No. 537' are inscribed in raised lettering and decorative motifs give a very attractive pattern. The house and weighbridge are listed on the NIAH (Reg. No.: 30330011) and on the RPS.

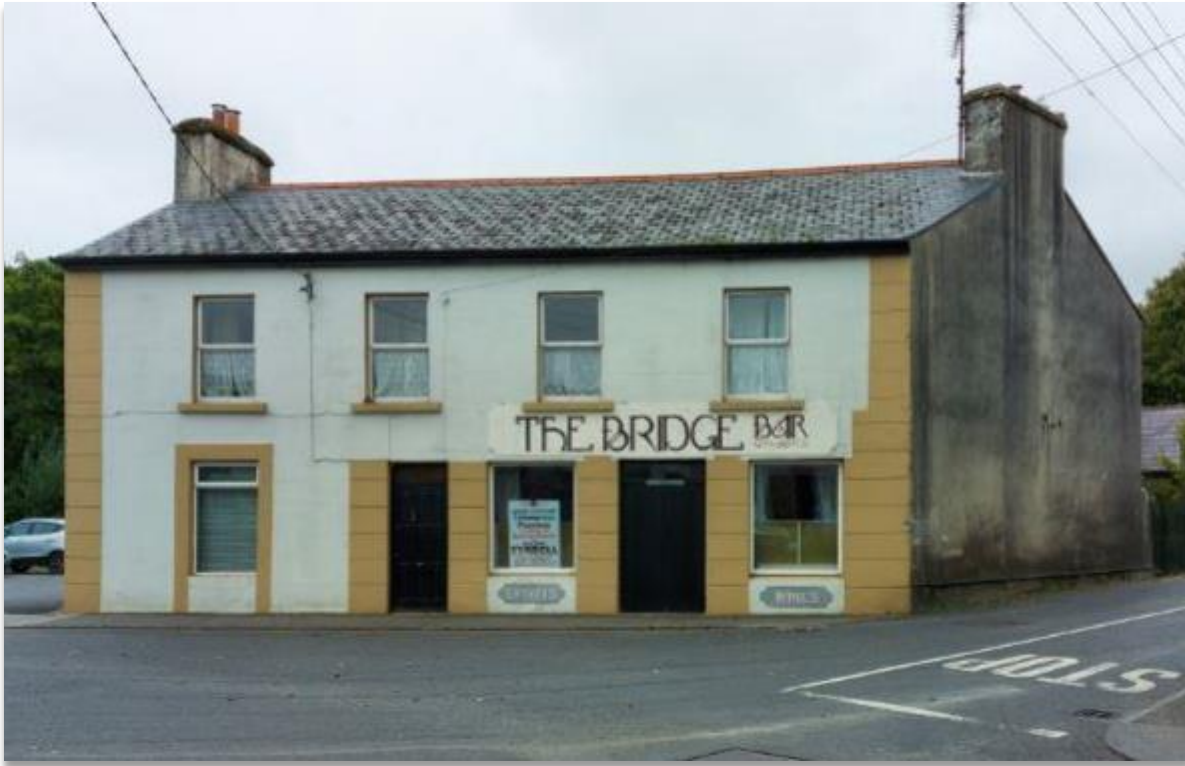
Photograph: The Bridge Bar, Dunmore

This building dating to the late 1800s was designed to fit into the layout of the earlier, possibly medieval street plan. John Loftus, the owner of the Bridge Bar built a Handball Alley to the rear of the building. The back wall of the alley is still standing. (Information from Hubert Birmingham).

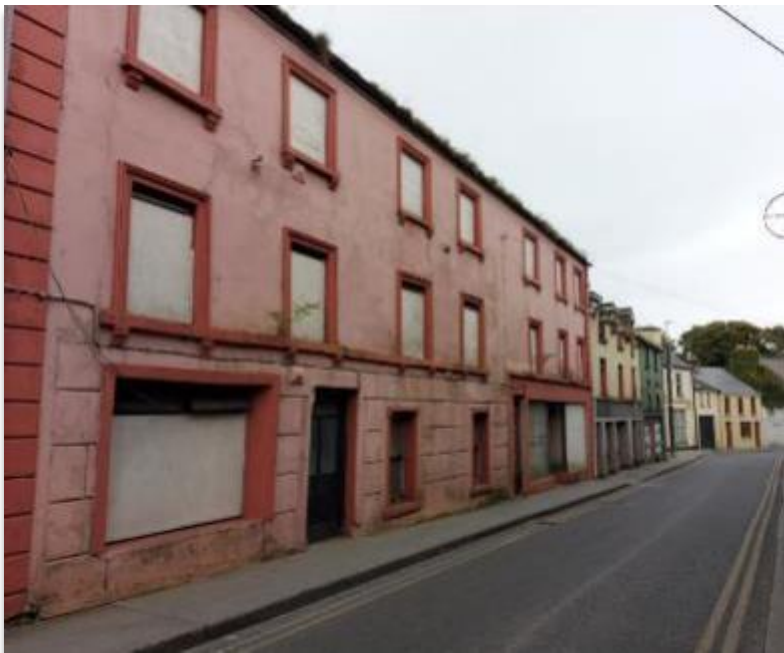
Photograph: Former McDonnells Department Store, Bridge St., Dunmore

This derelict building on Bridge St. exhibits many of the architectural features common in the town including square headed windows with moulded surrounds set on brackets, a continuous sill course to the first floor and a shopfront inserted into the ground floor. The recessed entrance doorway is 111 tiled with a

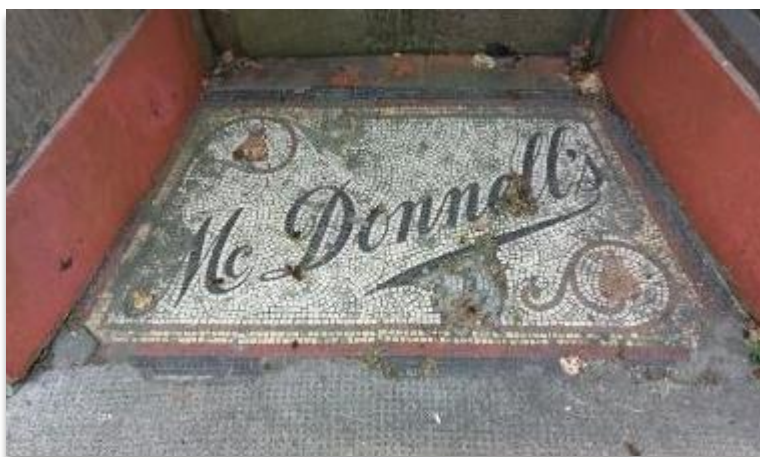
very attractive mosaic pattern inscribed with the owner's name. This was once the entrance to a large department store owned by Martin McDonnell, a merchant from Roscommon who prospered significantly in the mid-1800s. He later opened branches in Tuam, Milltown, Mountbellew, Ballyhaunis and Cloonfad. He held eight townlands in the parish of Boyounagh, one in the parish of Tuam and one in the parish of Dunmore at the time of Griffith's Valuation. He bought almost 6,000 acres of Lord Fitzgerald's estate in the vicinity of Dunmore in the early 1850s. By the 1870s he owned over 9,000 acres in county Galway, 2,940 acres in county Roscommon and three acres in county Mayo. (<http://landedestates.nuigalway.ie/>) His life and times are detailed in the book 'The Life and Times of Martin McDonnell, Merchant, Landlord and Poor Law Guardian' by William Keaveney. (Information from Joan Walkin)

Photograph: Mosaic tiled entrance door step Bridge St., Dunmore

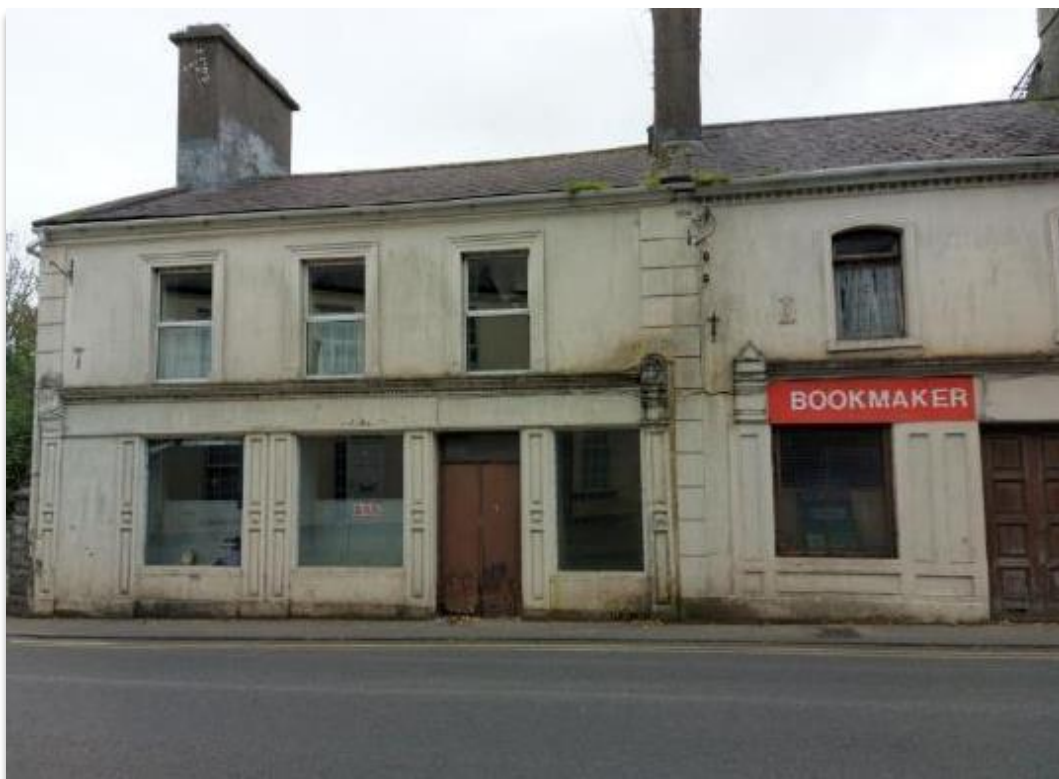
Photograph: Former houses with integral shopfronts, Bridge St., Dunmore

A number of derelict houses with integral vernacular shopfronts are located on Bridge St. A noticeable feature of these buildings are the high chimneystacks. The buildings on the east side of Bridge St. are due for demolition under the Dunmore Rural Regeneration Scheme which is underway by Galway County Council.

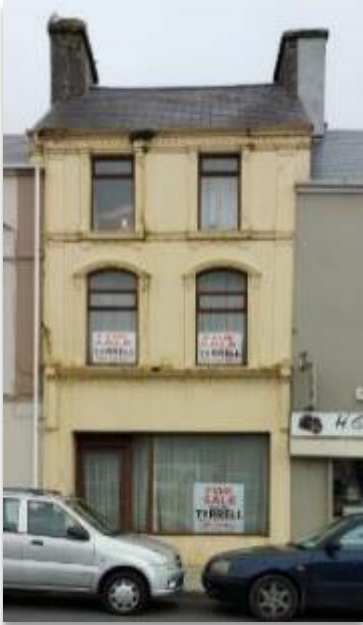
Photograph: An unusually narrow three storey, two bay building with integral shopfront, the Square, Dunmore

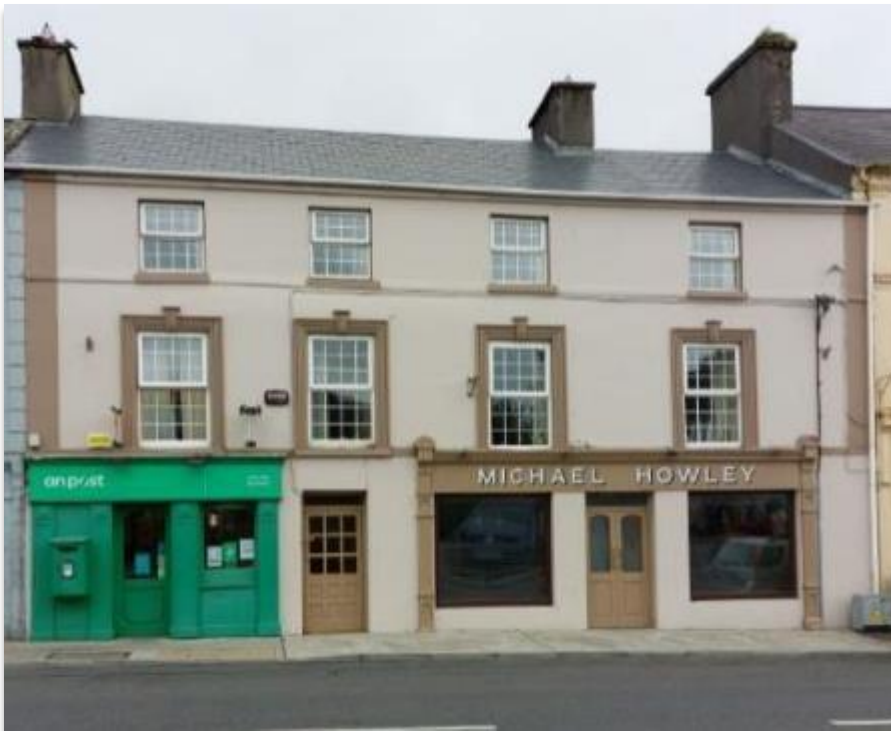
Photograph: Traditional shopfront with hand painted name plate and modern post office shopfront set into ground floor of house. Second floor windows with decorative channelled architrave with central pediment.

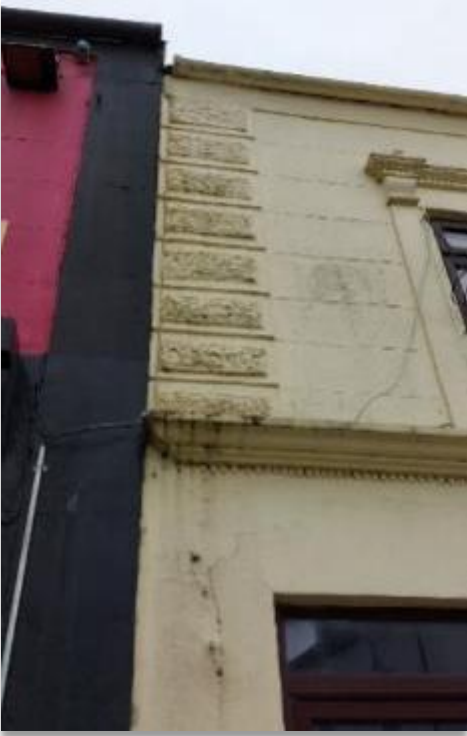
Photograph: Plaster decoration on quoin stones of building in The Square.

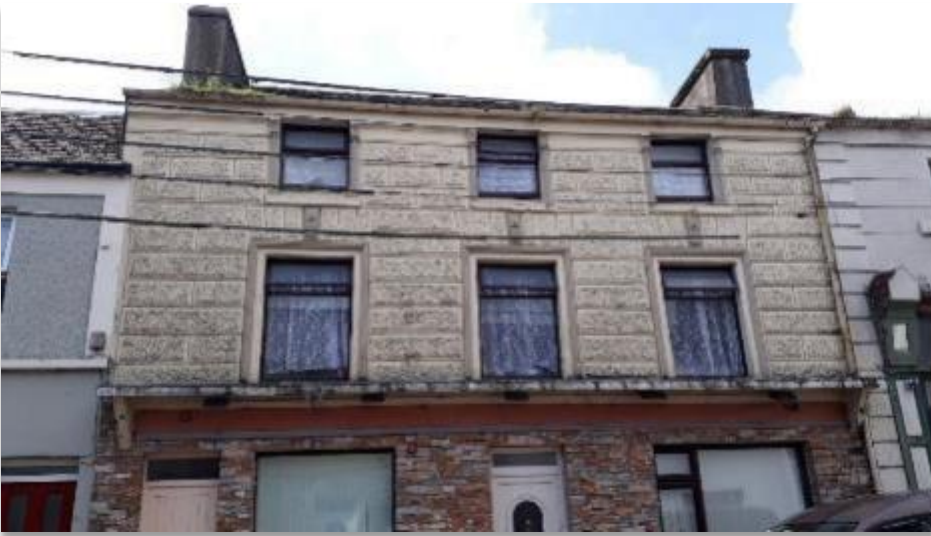
Photograph: Plaster decoration on lined and rendered façade of upper floors of house in Castle St. with remains of fascia of a traditional shopfront over ground floor.
